IRAQI CIVIL DEFENSE  
HEADQUARTERS  
BAGHDAD, IRAQ

**SIGIR PA-06-090**  
**APRIL 26, 2007**

SUBJECT: Report on Iraqi Civil Defense Headquarters, Baghdad, Iraq (Report Number  
SIGIR PA-06-090)

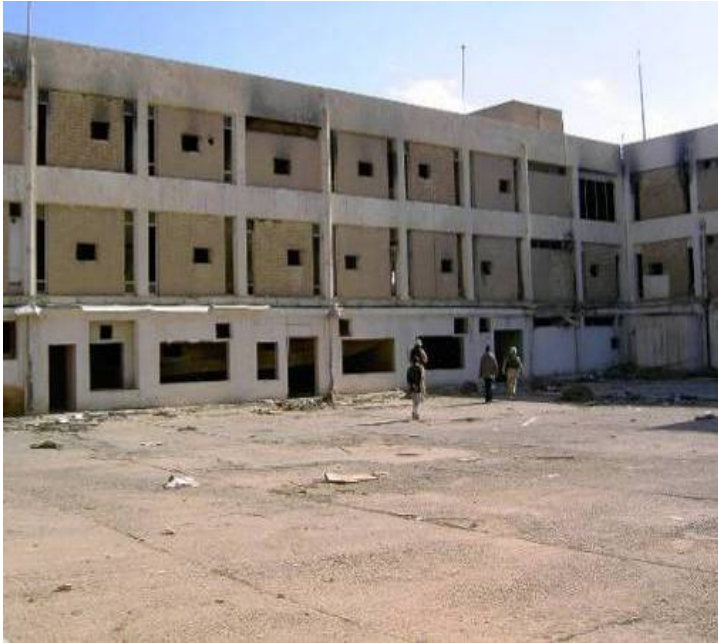
Ministries of Human Rights and Trade, and the abandoned Iraqi National Congress building. The existing facility consists of one three-story main headquarters building, a separate two-story building providing additional office and training space for department personnel, and three small, independent rooms housing the generator, transformer, and pump. The main headquarters building is an L shaped building located on the middle of the complex; while the other buildings are located along the western section of the complex (Figure 1). The original facility was constructed in 1991; however, severe looting and burning after the 2003 war left the ICD HQ buildings severely dilapidated and in need of significant rehabilitation (Site Photos 1 through 4).

**Site Photo 1. Exterior view of the existing ICD HQ building**  
 (Photo courtesy of the USACE)

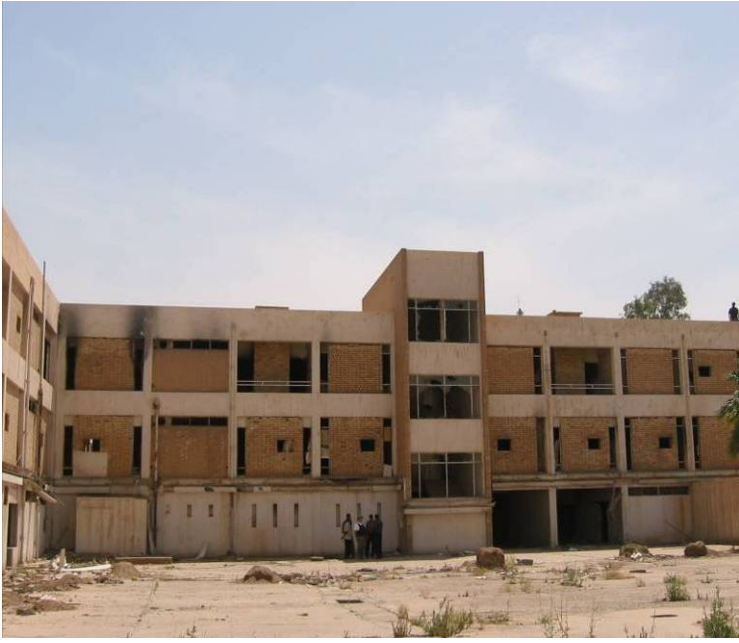
**Site Photo 2. Exterior view prior to renovation**  
 (Photo courtesy of the USACE)

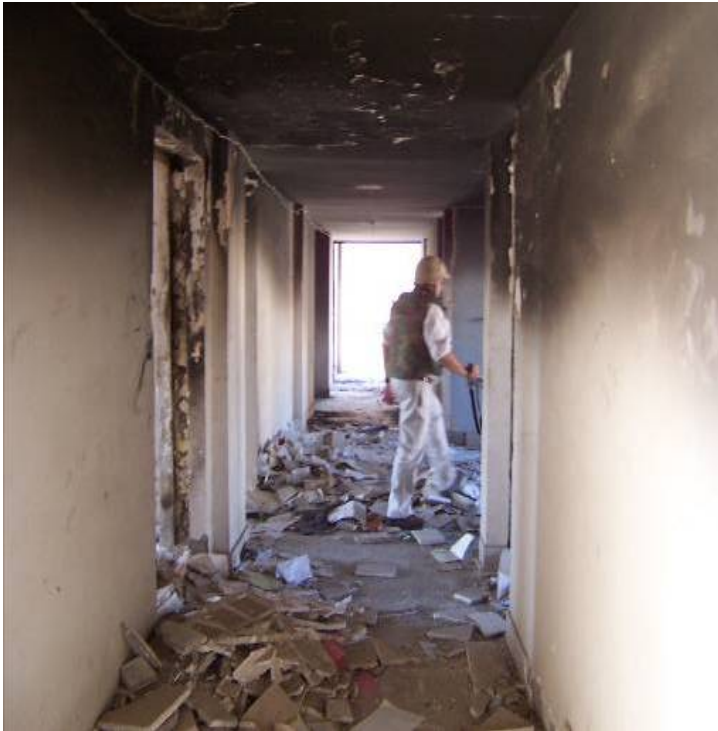
**Site Photo 3. View of ICD HQ hallway after severe looting in 2003**  
 (Photo courtesy of the USACE)

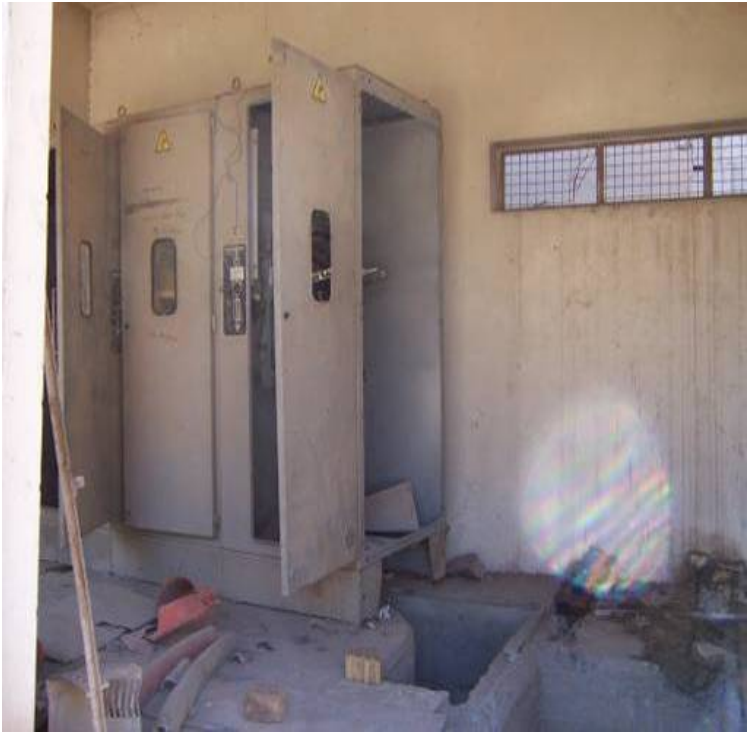
**Site Photo 4. Previously existing generator room**  
 (Photo courtesy of the USACE)

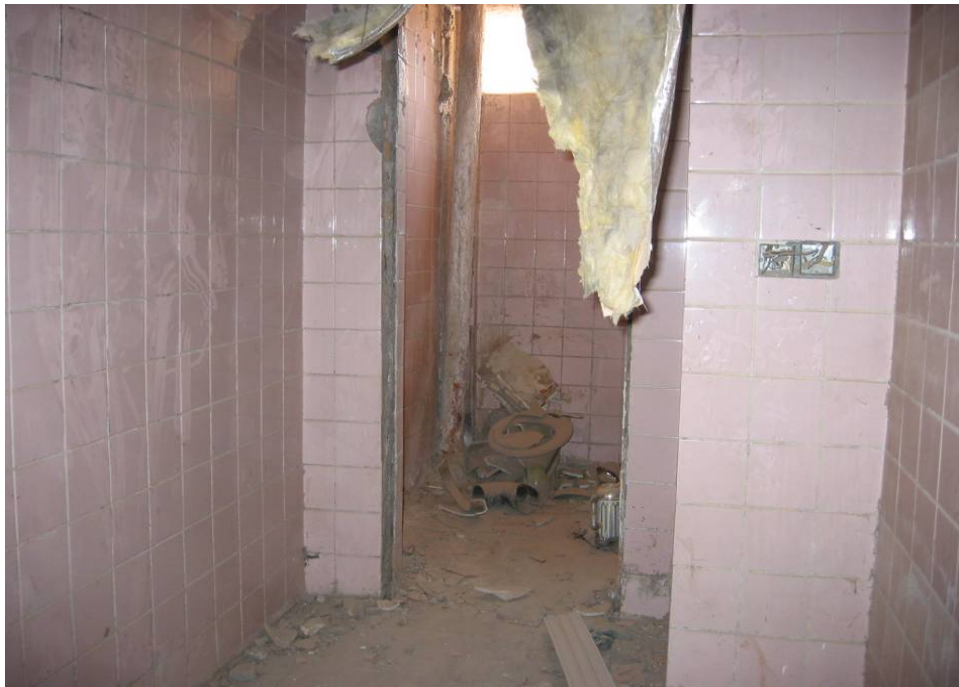
The original ICD HQ bathrooms were destroyed as a result of the looting and burning in 2003 (Site Photos 5 and 6), which required new bathroom facilities. The TO SOW required the contractor to furnish the labor and materials to completely restore the ICD HQ bath and toilet rooms. The TO SOW specifically stated the “design and construction must comply” with the IPC. In addition, the TO specifically stated that the “plumbing system shall be installed and/or repaired complete with necessary fixtures, fittings, traps, valves, drains and accessories to be fully operational and free of leaks.”

**Site Photo 6. Condition of bathroom prior to renovation (Photo courtesy of the USACE)**

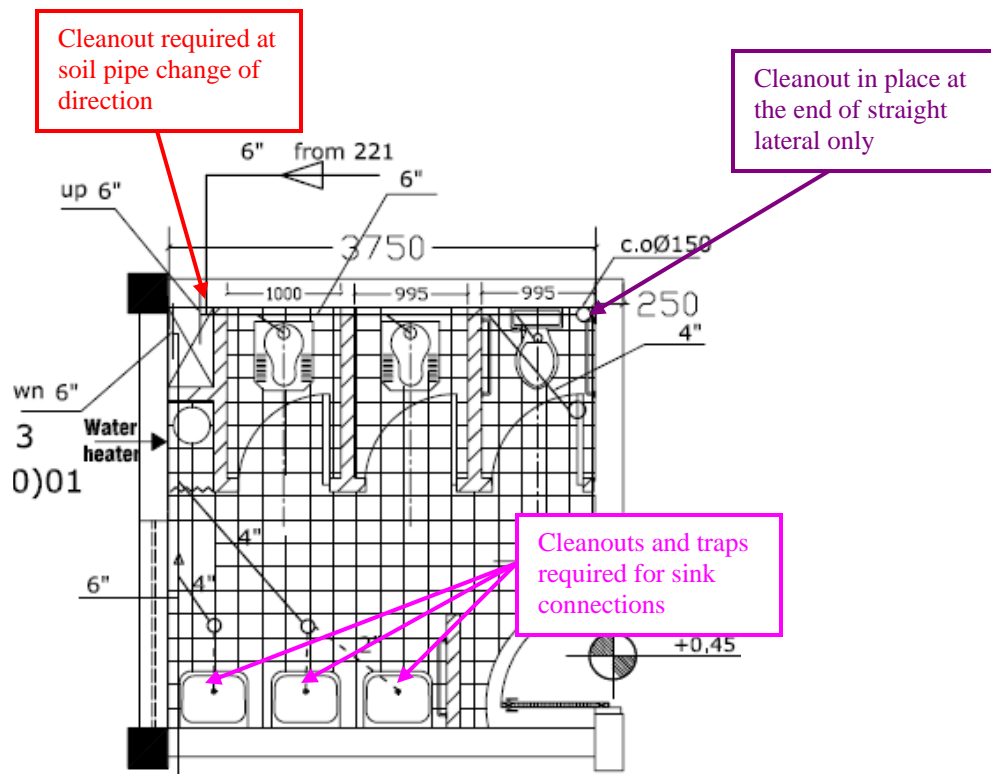
The as-built drawings for the ICD HQ bathrooms indicate cleanouts were only used at the far end of a straight run of soil pipe, not for every toilet trap and change of direction (Figure 7). Since the 30% and 60% design drawings were unavailable for our review, we cannot determine whether the government engineers reviewing the bathroom design drawings failed to detect and identify the lack of sufficient number of cleanouts and traps at the correct locations. However, the government design reviews do not mention the absence of cleanouts and traps at the correct locations as a deficiency.

**Figure 7. Contractor as-built drawing for ICD HQ building A bathroom**

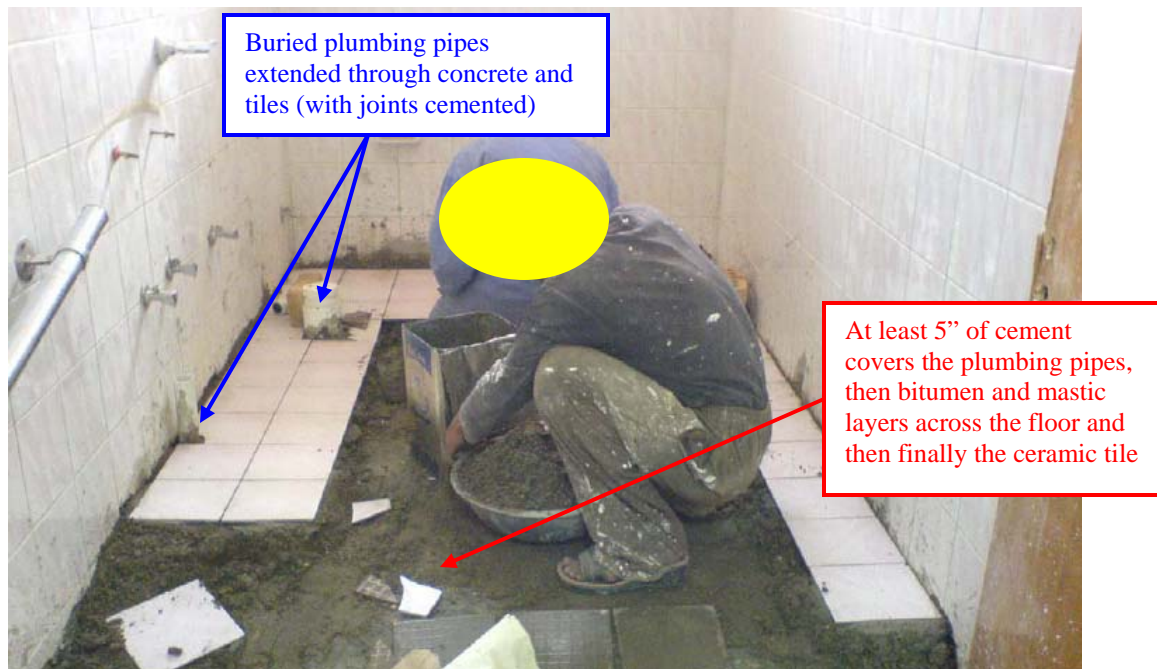
In addition to cementing the joints, the subcontractors buried the sewer pipes under the cement floor. Any leak from a joint or crack allows water to leave the pipe and migrate into the available cracks and voids within a raised concrete floor. Since PVC pipe material cannot bond with concrete, water and moisture migrate along the outer surface of the pipes. This practice not only significantly increases the weight of each floor of the building; it also places additional weight upon the unsupported segments of PVC plumbing pipe and undue stress of joints – both lead to increasing the risk of joint cracks and leaks. The construction methods and techniques used are antiquated and grossly inefficient. This type of construction does not offer the opportunity for routine maintenance or for repairs to the plumbing system without significant and major demolition. For example, any sewer line leak that develops would require the entire floor

**Site Photo 12. Bathroom after concrete has been poured and tile being applied**  
(Photo courtesy of the USACE)

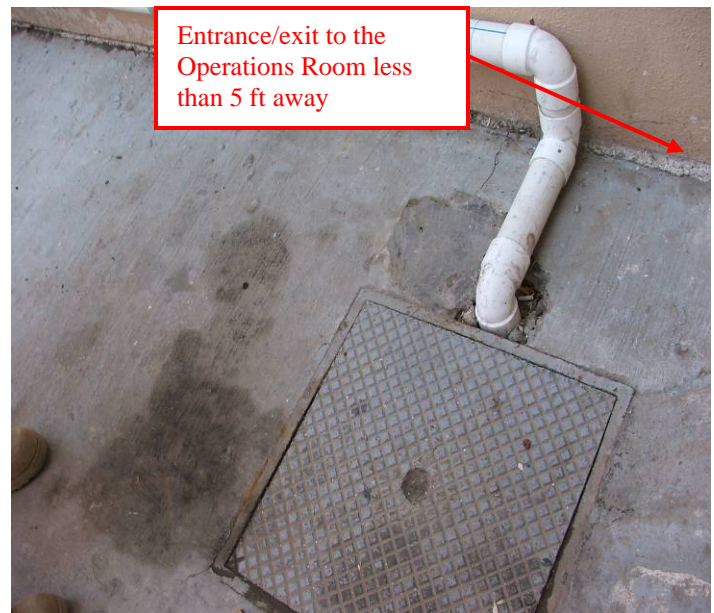
We identified approximately 15 feet of exposed plumbing sewer pipes leading from the ground floor bathroom to the outside manhole (Site Photos 14 and 15). The exposed sewer pipes are not protected. For example, the sidewalk shown in Site Photo 15 is less than five feet from the entrance/exit of the Operations Room. Any ICD HQ personnel not paying attention may trip over the exposed pipe, resulting in potential injury or breaking the pipe. In addition, PVC pipe is not designed to withstand excessive temperatures and the typical Iraqi summer will eventually cause the pipes to crack. Broken and/or cracked exposed sewer pipes will create environmental and health hazards for the ICD HQ personnel.

**Site Photo 15. Exposed PVC plumbing pipe from ground floor bathroom to the sewer manhole**

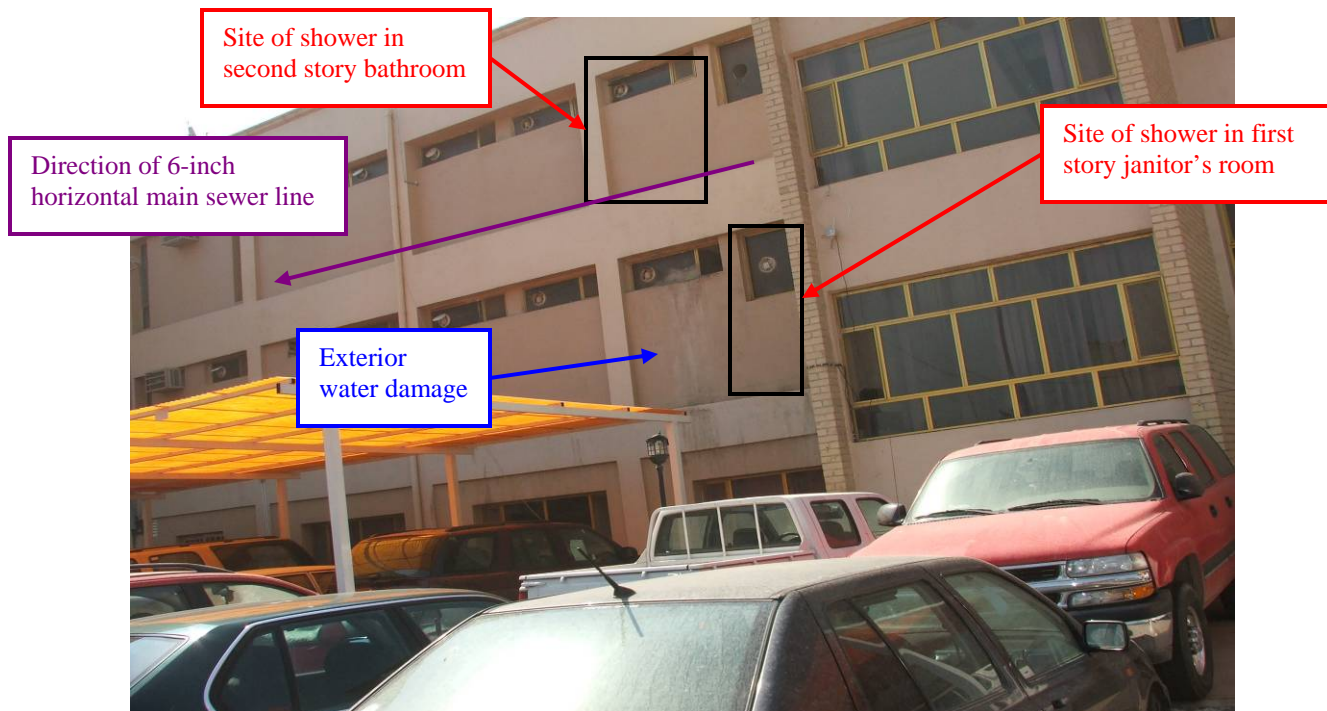
ICD HQ personnel acknowledge contracting on their own to install two showers, one in a previously existing janitor room and one in a bathroom consisting of a toilet, bidet, and sink. The ICD HQ installed showers do not include shower pans; consequently, the shower water is forced to empty through the floor drain. The shower in the bathroom is on the second floor; while the shower in the janitor's room is on the first floor (Site Photo 26).

Site Photo 26. Exterior view of the ICD HQ facility

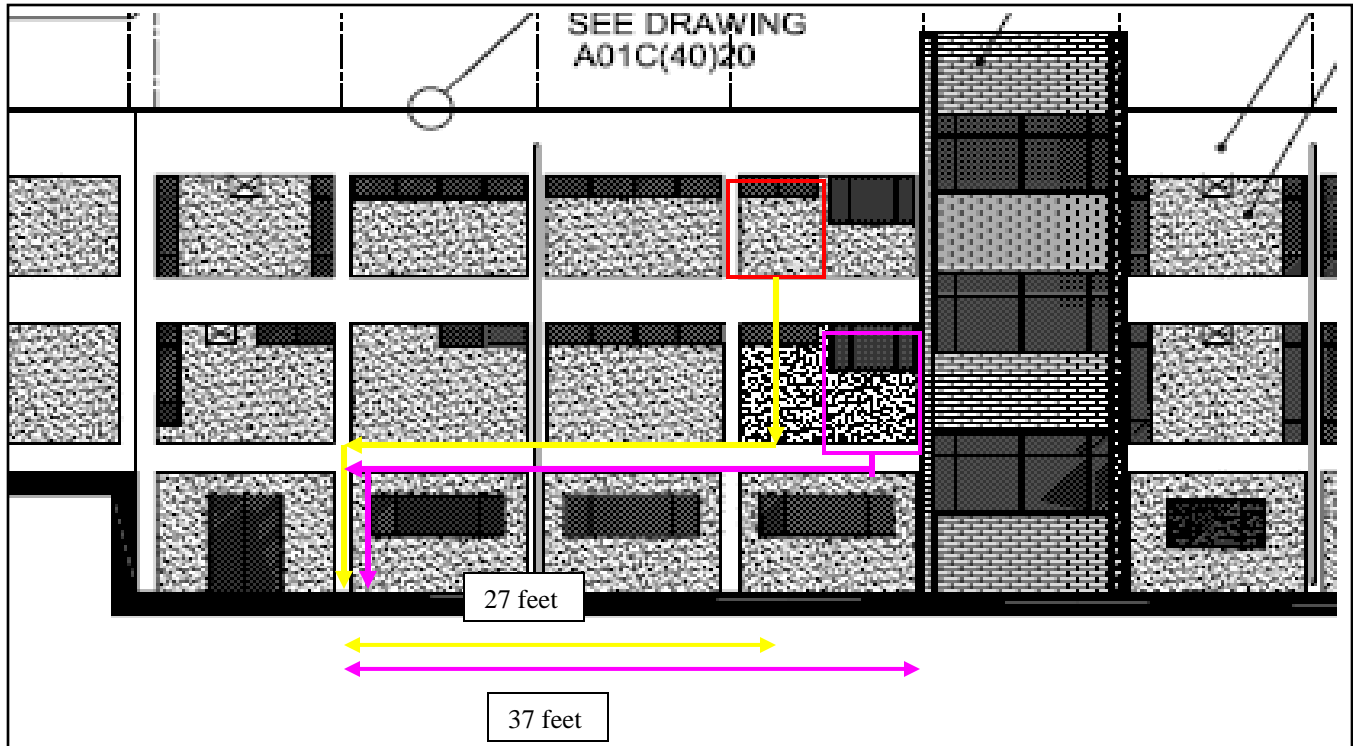
GRC representatives assert the water damage inside the ground floor Operations Room and the exterior of the main building is caused by the two showers. Specifically, the shower water splashes onto the wall tiles and directly onto the floor. According to GRC representatives, neither the floors nor the walls in the janitor room and bathrooms are water proofed. As a result, shower water leaked through the wall onto the exterior of the building (Site Photo 26) and through the floor. The design of each floor plumbing system connected the bathroom showers, drains, and toilets lines to the main 6-inch sewer line, which runs horizontally across each floor (Site Photo 26). The main 6-inch sewer line, like the rest of the plumbing, is covered under the raised cement floor. The GRC PE believes the shower water leaked through the second and third floors, traveled from the far side of the ground floor ceiling (near the stairs) across the ceiling to the ground floor Operations Room pillar (Figure 8). The GRC PE's explanation for this occurrence is that the water traveled to the "point of least resistance."

**Figure 8. Exterior view of the ICD HQ facility, specifically, the first and second story rooms the GRC PE believes are responsible for the water damage to the ground floor Operations Room**

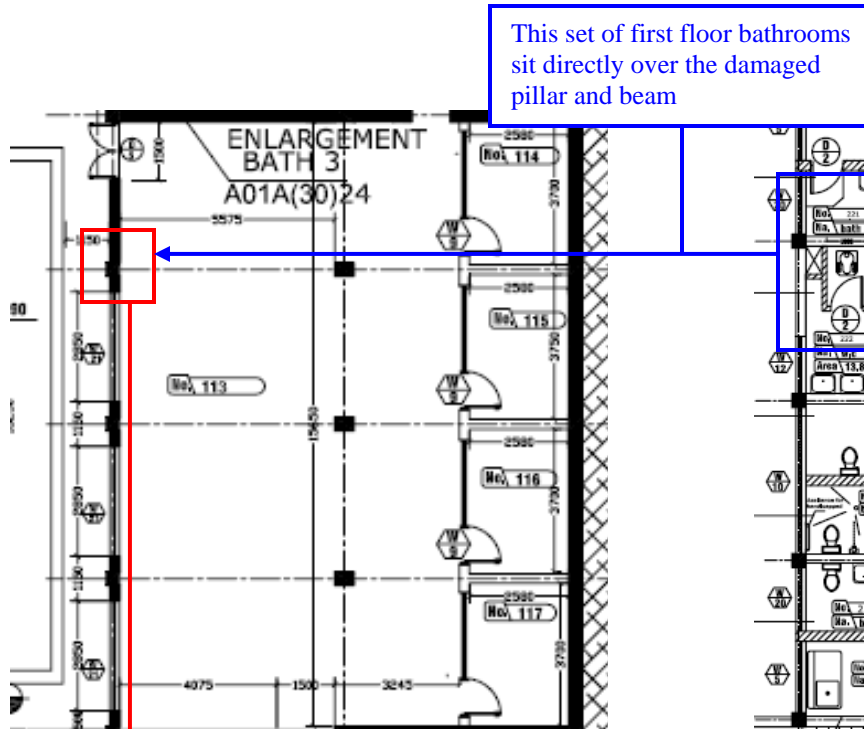
Figure 9. Diagram location of water damage to the ground floor Operations Room

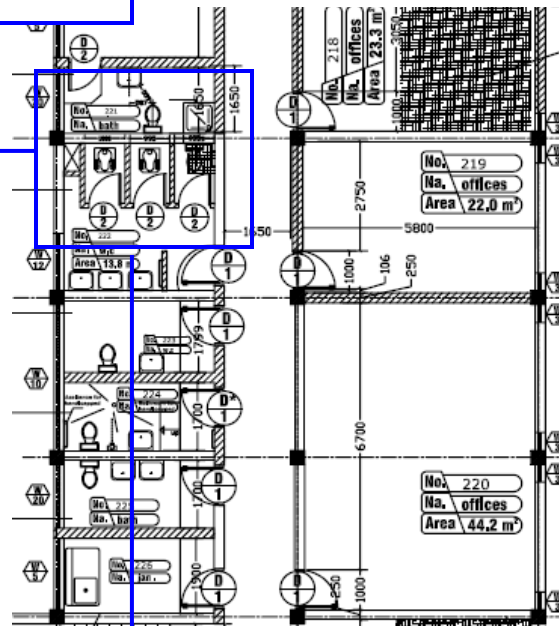
Figure 10. Diagram location of first story bathroom (directly over the damaged wall on the ground floor)

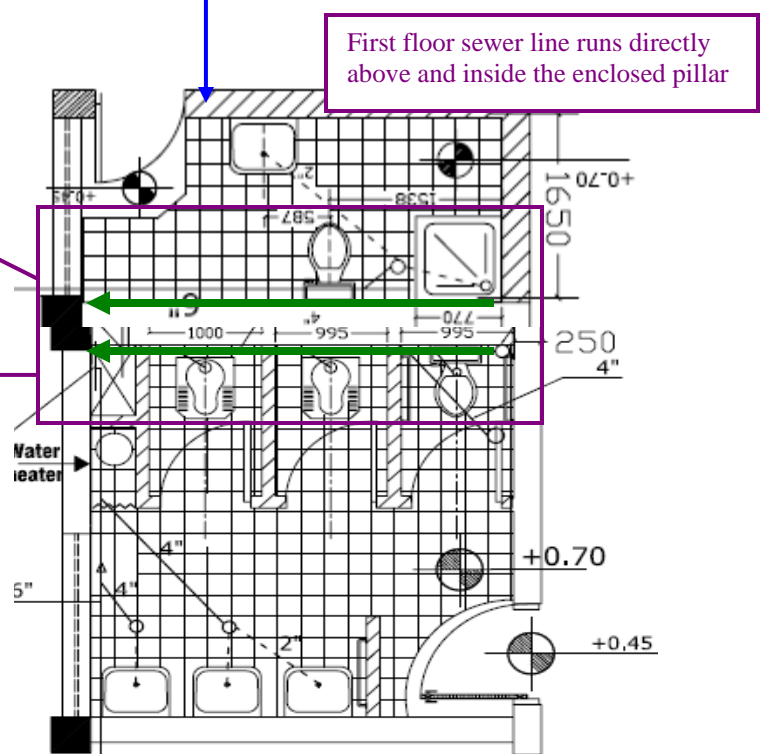
Figure 11. View of bathroom plumbing sewer pipe line (located directly over the ground floor Operations Room)

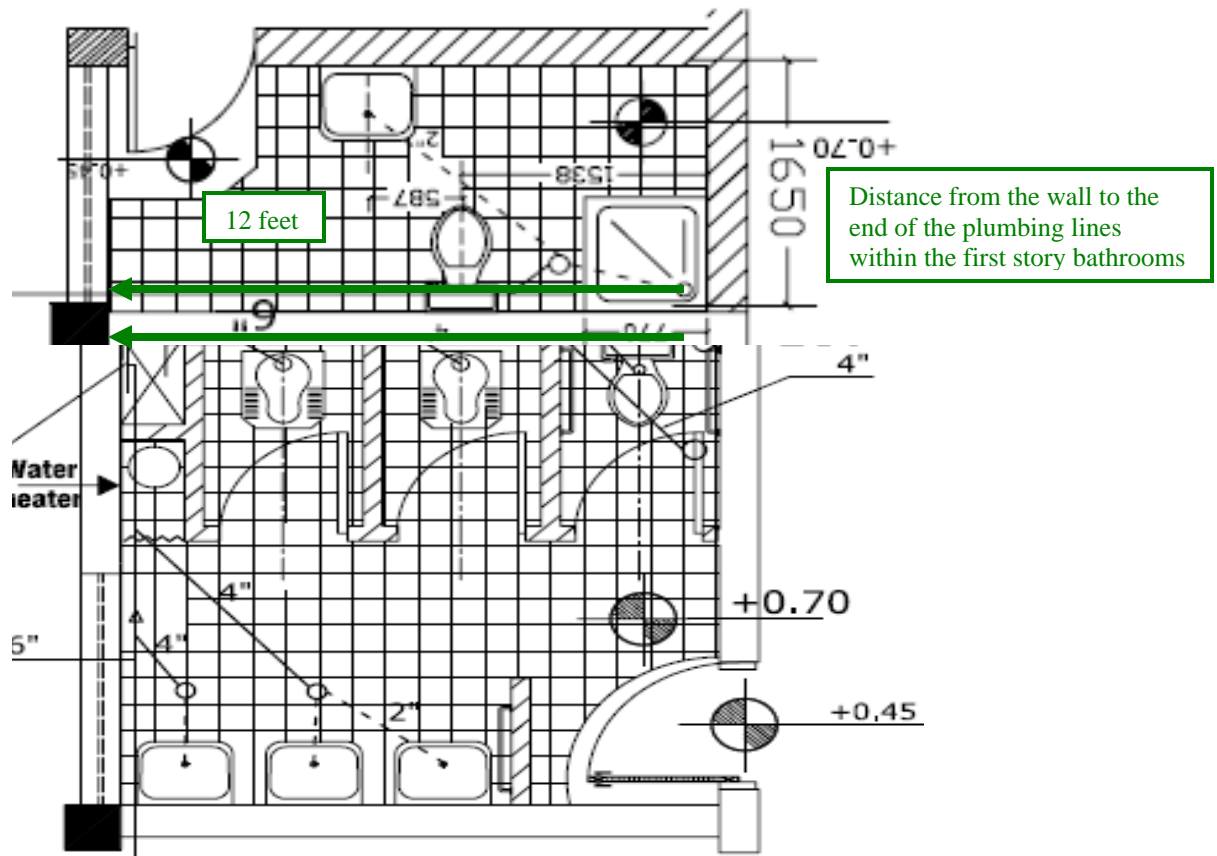
**Figure 12. Illustration of plumbing lines, which are located directly above the ground floor water damage**

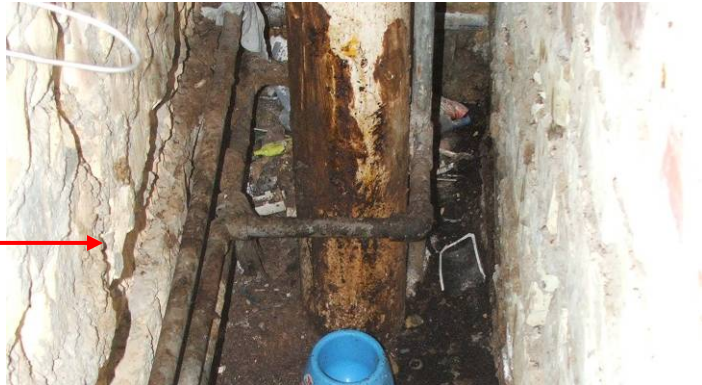
In addition, during our site visits, we identified evidence of water leaks in the first floor chase (Site Photos 32, 33, and 34). The leaks appear at both the ceiling and floor of the chase. The location of the first floor chase is directly on top of the Operations Room pillar. Any water leakage from the first floor chase would drop straight onto the Operations Room pillar and beam.

**Site Photo 34. Close up view of bottom of Site Photo 32**

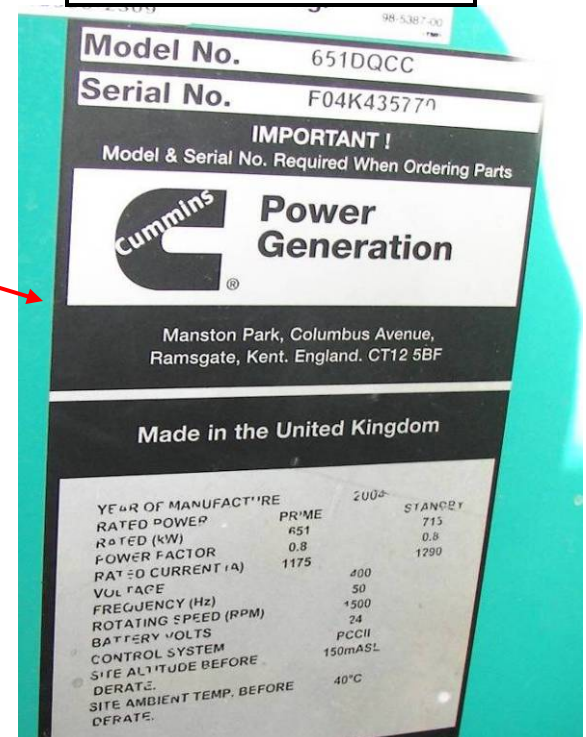
Exhaust system (red arrow) and radiator (black arrow) added to the generator in an effort to cool it down. While this has helped, the generator still suffers from overheating.

Site Photo 52. Enlargement of generator face plate

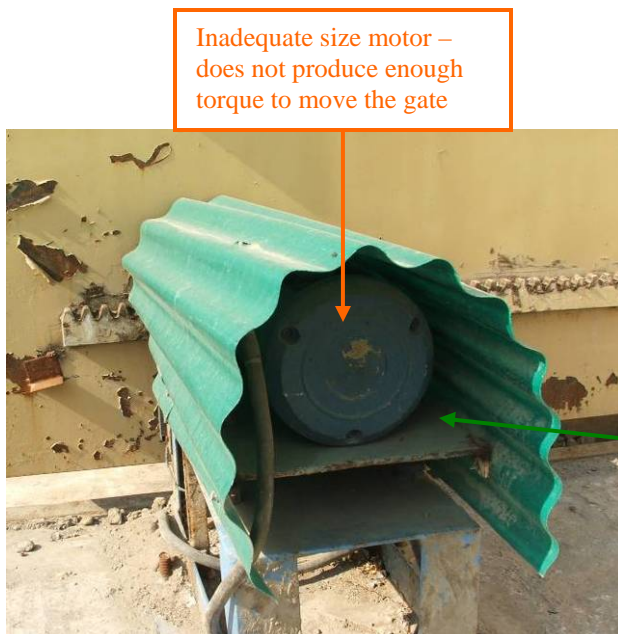
During our initial site visit, ICD HQ personnel stated the Sally Port gates are not operational. The design for the operation of the gate was not available and the as-built drawings do not include any specifications for the motor. In our opinion, the mechanism to move the gate from one end to the other was not adequately designed and configured. A properly designed steel rolling gate would have included load calculations, such as the weight of the gates while in motion, to determine the correct size motor to operate the gates. In addition, considering the weight of the gate doors, at least four wheels were necessary to move it across the track. The subcontractor provided motor does not have adequate horse power to move the gate; consequently, the motor cannot produce the required torque to operate the gates. In addition, the gates appear to have not been properly treated with a prime coat of paint prior to installation since they had rust spots

Site Photo 53. Enlargement of Sally Port gate motor

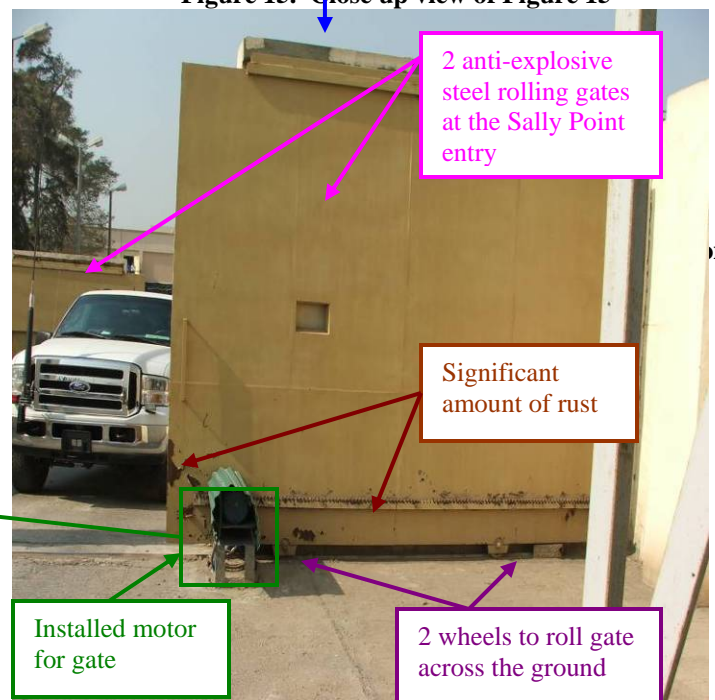
and peeling paint. Since the gates were not properly primed or painted, the continual rust will eventually lead to weakening of the gates (Site Photos 53 and 54).

Site Photo 54. Sally Port gate

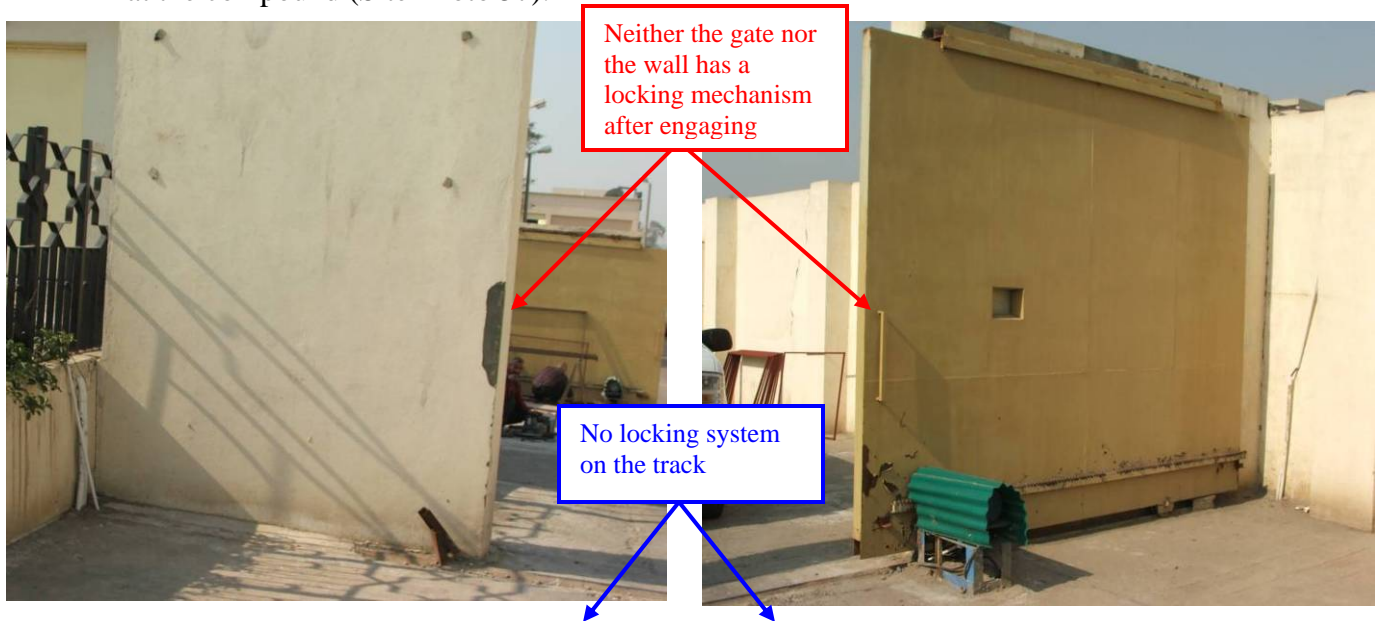
Another poorly designed aspect of this gate system is that it does not provide any locking mechanism once it reaches the destination point (the other wall). The intent of this gate was to provide explosive-proof security for the ICD HQ compound, which means prohibiting a suspected vehicle from entering the compound. In order to adequately stop the vehicle from entering, the sliding gate has to lock into either the ground or the other wall upon contact. This door does not meet the necessary means to prevent forced entry or provide resistance to an explosion. There are no mechanisms to keep the door in the intended (locked) position (Site Photos 55 and 56).

Site Photo 55. Left side of Sally Port gate

Site Photo 56. Right side of Sally Port gate

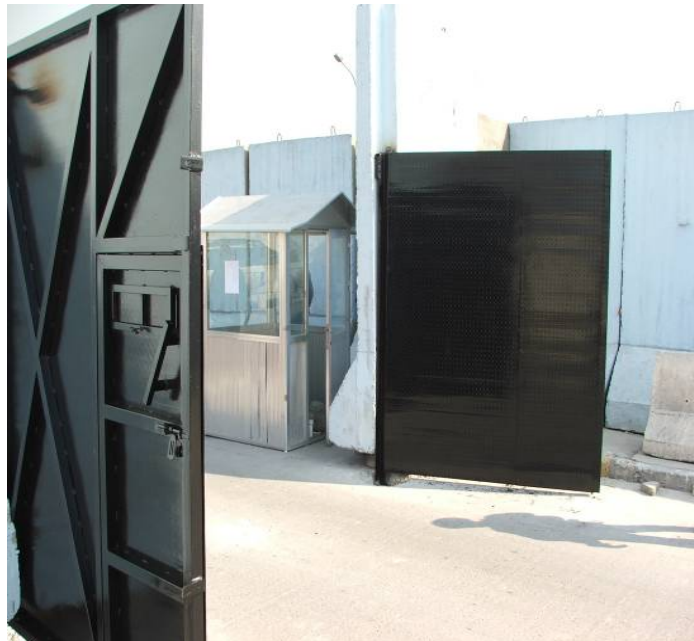
Since security is of the utmost importance at the ICD HQ and the Sally Port gates failed to provide it, the ICD HQ, at its own expense, installed manually operated security gates at the compound (Site Photo 57).

Site Photo 57. Manual gate installed by the ICD HQ

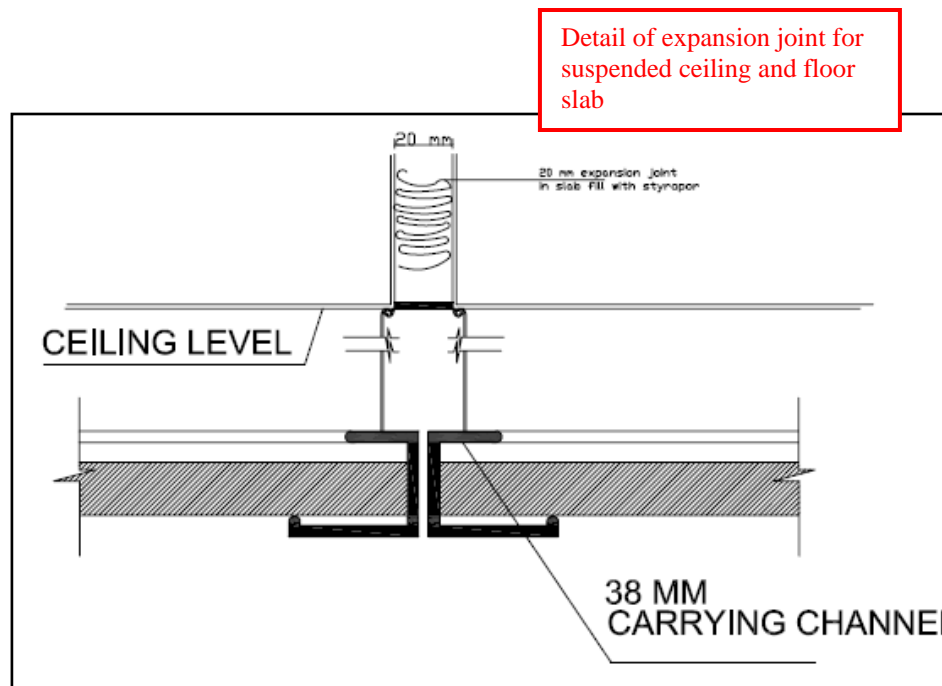
We found no evidence of the installation of any type of expansion joint system at any location in this building.

**Figure 16. Contractor’s as-built drawing for expansion joint for ceiling and floor slab**

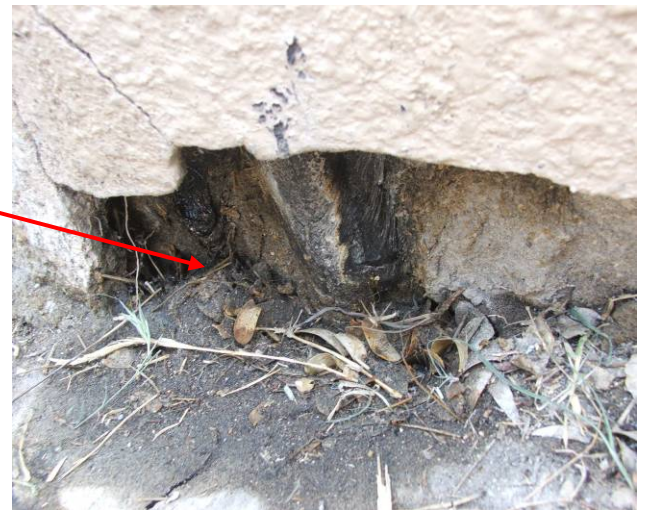
“complete” as-built drawings, no expansion joints were used on the floor, wall, or roof of the ICD HQ building. However, both GRD and ICD HQ personnel stated that at least one expansion joint was installed on the exterior wall of the ICD HQ building (Site Photo 58). The location of this expansion joint is questionable because it does not appear to be in the correct spot (Figure 18). Further, the installation of the expansion joint does not appear to be done correctly (Site Photo 59). The intent of an expansion joint is to allow a building to withstand thermal expansion and contraction and foundation movements; however, the fact that the subcontractor put plaster on top of the expansion joint negates its effectiveness.

**Site Photo 59. Enlarged view of expansion joint material**

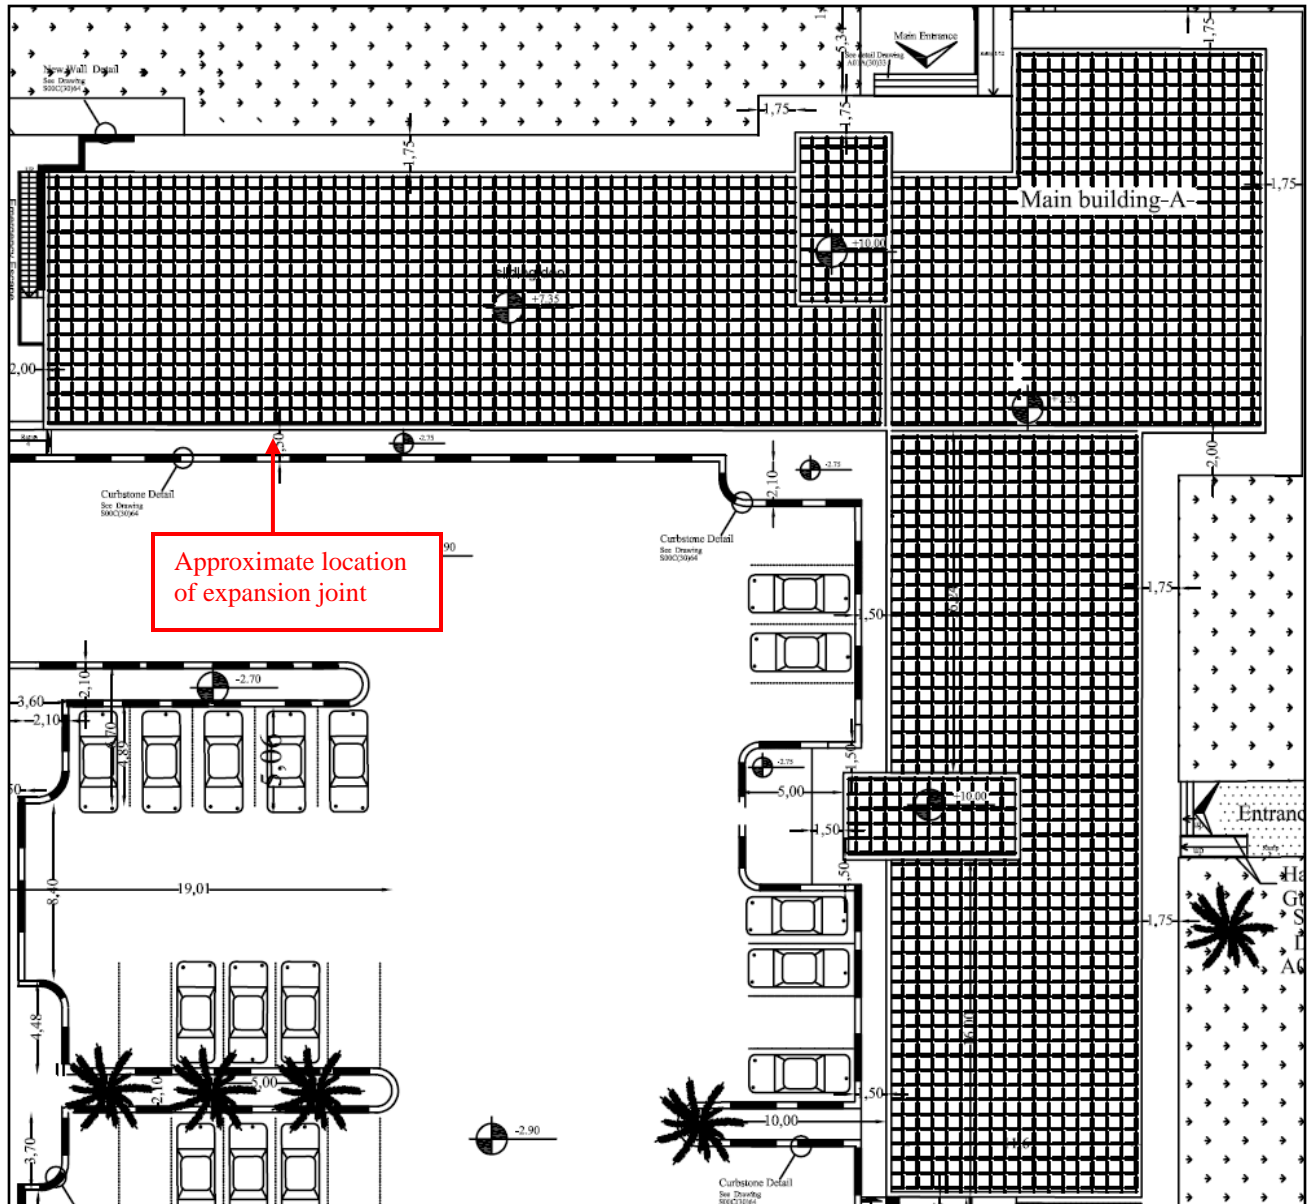
**Figure 18. According to GRD and ICD HQ personnel, the location of the expansion joint at the compound**

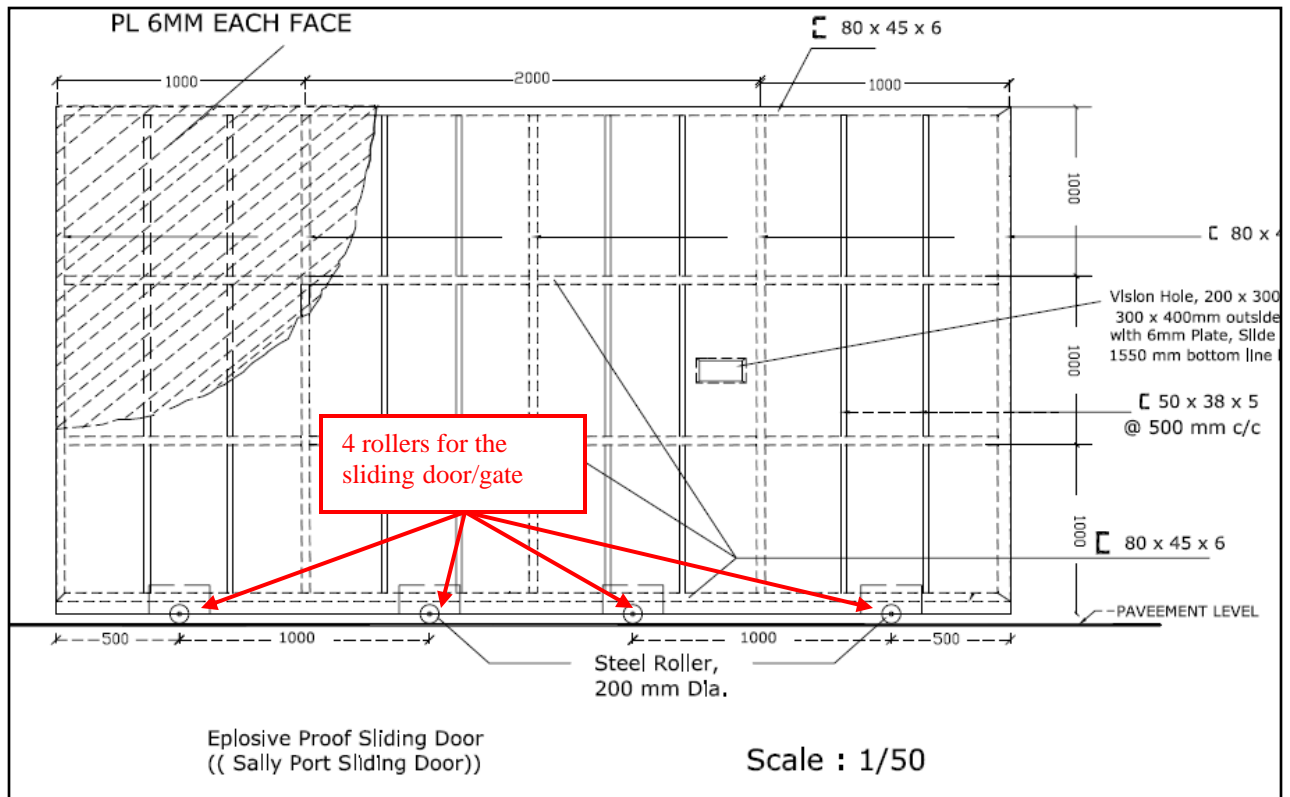
The as-built drawings for the Sally Port sliding gate indicate that each gate has four rollers/wheels and one vision hole (Figure 19). However, during our site visits, we identified that each gate had only two rollers/wheels and at least one gate had no vision hole (Site Photo 60). The lack of two additional rollers means the weight of the anti-explosive gate is distributed over two fewer wheels, resulting in additional stress on the two rollers. The vision hole is critical to enable the sliding gate guard to identify those attempting to enter the ICD HQ compound. Without a vision hole, the guard will have to partially open the sliding door in order to identify anyone approaching; this significantly increases the danger to the guard and the compound.

**Figure 19. Sliding door fabrication detail (from as-built drawings)**

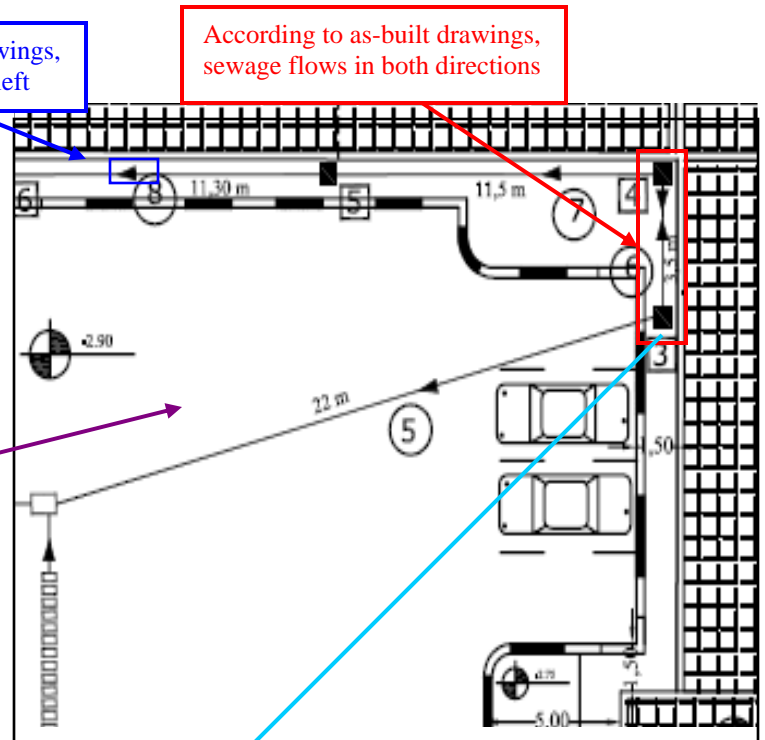
The sewage line site plan as-built drawings for the ICD HQ main building does not provide a correct sewage flow diagram (Figure 20). For example, in one instance sewage appears to flow in opposite directions (Figure 21), which is not possible considering the sewage lines run directionally by gravity. We lifted the manhole cover (Site Photos 61 and 62) and determined that the sewage actually flowed from Box 4 to Box 3. In another instance, the direction of the sewage flow is not correct. Figure 21 shows sewage directional flow running from Box 4 to the left toward Box 5; however, when we lifted the manhole cover, we determined the flow of the sewage line was running from Box 5 to the right to Box 4 and then downward to Box 3 (Figure 22 shows the correct directional flow of sewage lines).

Figure 21. Contractor's as-built drawing (directional) for the sewer lines at the ICD HQ compound

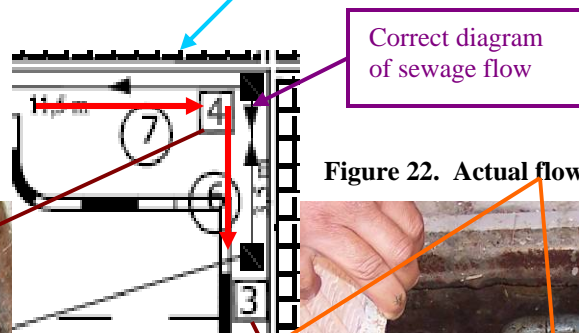
Figure 22. Actual flow of sewage lines

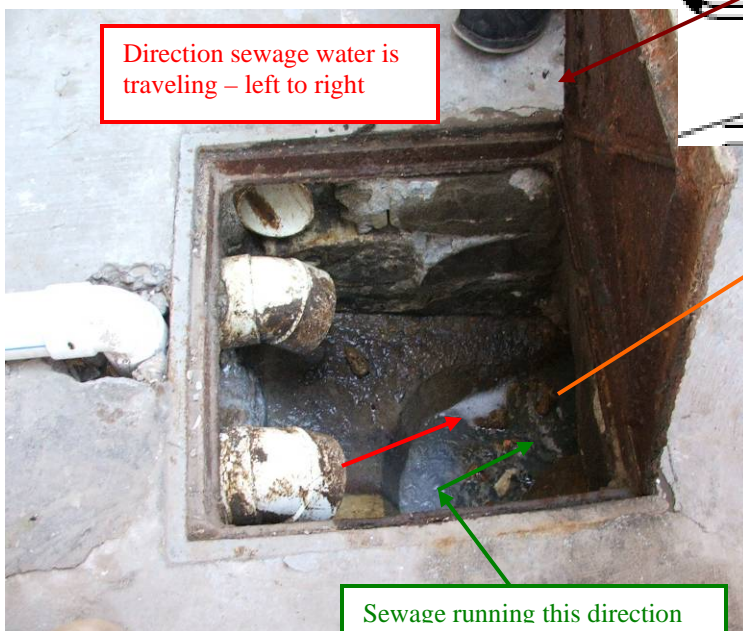
Site Photo 61. Manhole #4 from contractor's as-built drawing

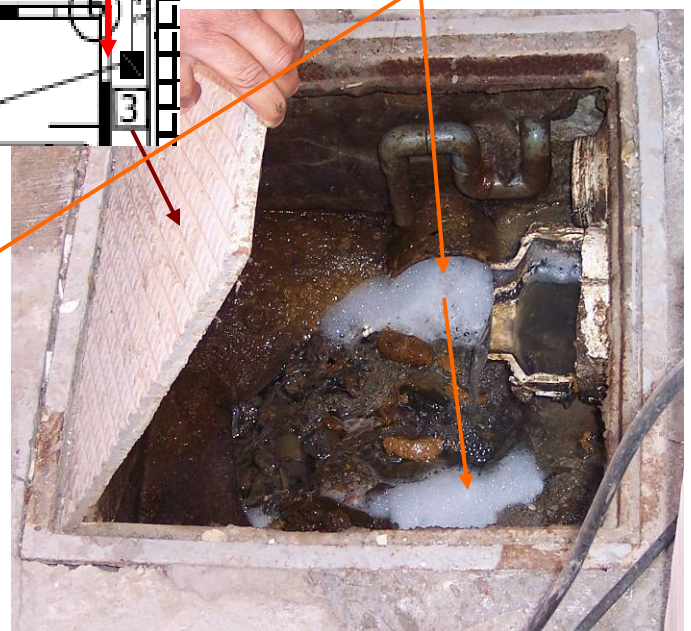
Site Photo 62. Manhole #3 from contractor's as-built drawing
